Re: Notice of Claim and document request
Kingpoint Technology/KVT/Silan/Itochu - Jan's Packaging
Jan's Pro #s: 121375 p/u 10/05/15, 121427 p/u 10/9/15
and 121441 p/u 10/12/15
Your Ref: tba
Our Ref: 3362

PRELIMINARY SURVEY REPORT

Werlinger & Associates Informal Memorandum **Itochu Logistics: Transit / Impact (D.O.L.: TBD)**

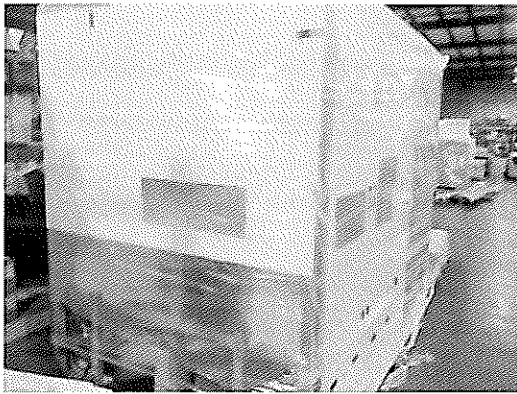
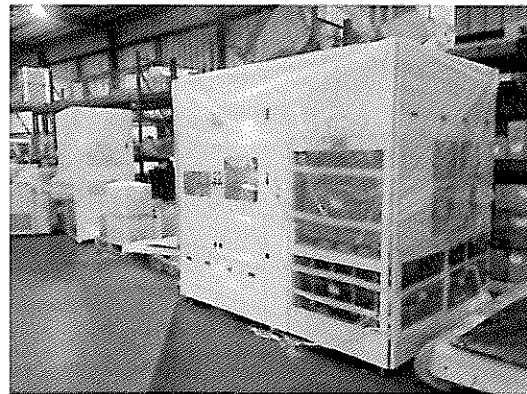
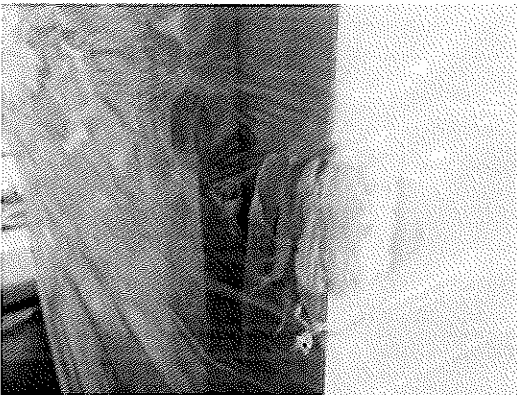
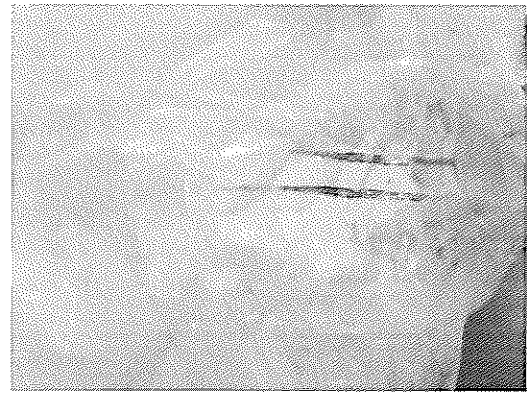
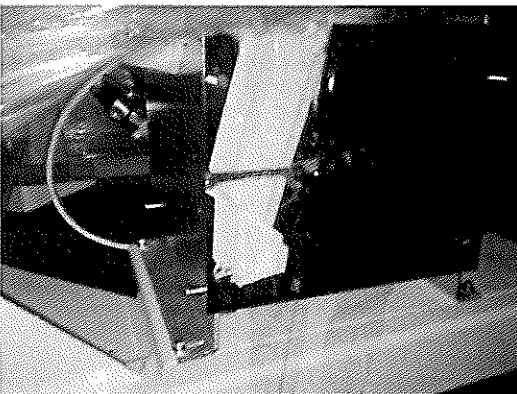
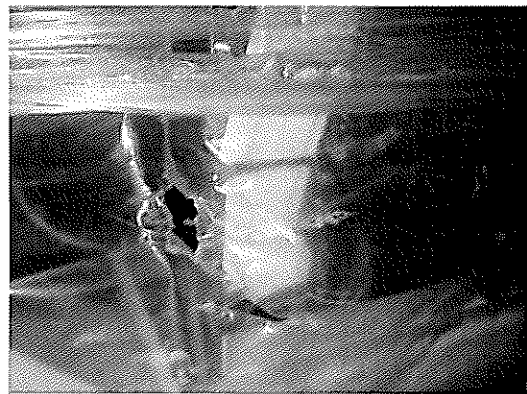
Package no's 8-1 & 8-2, description: Anneal Chamber & Main frame. Both units found wrapped with clear plastic stretch wrap, no bubble wrapping used. The side panels on both of the machines found scratched. The stretch wrap found torn with chafing damages in the area of the damages. Similar type damages sustained to both machines.

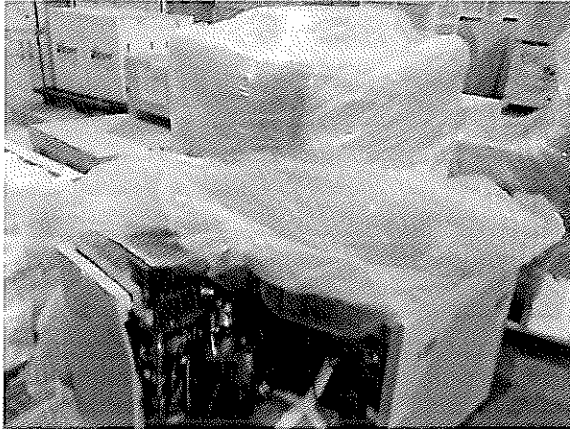
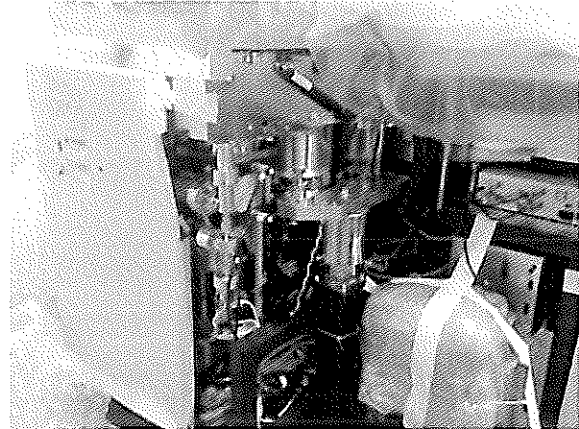
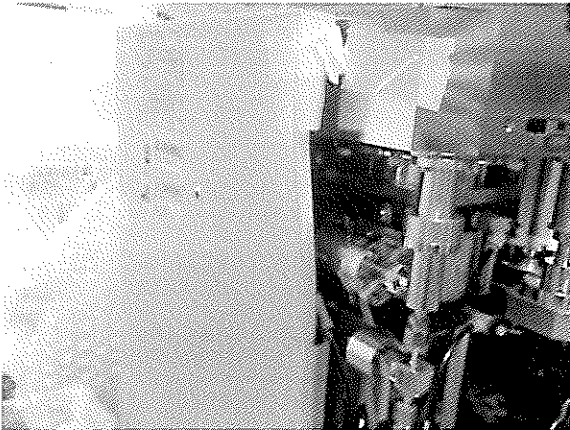
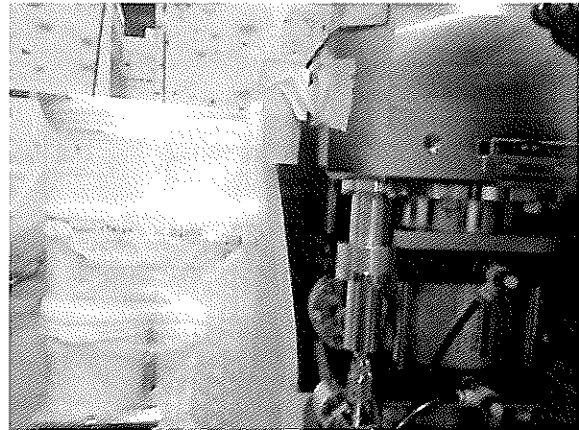
Package# 5-1, description: Main body. The unit wrapped with stretch wrap and bubble wrap. The machine side metal panel found dented inward.

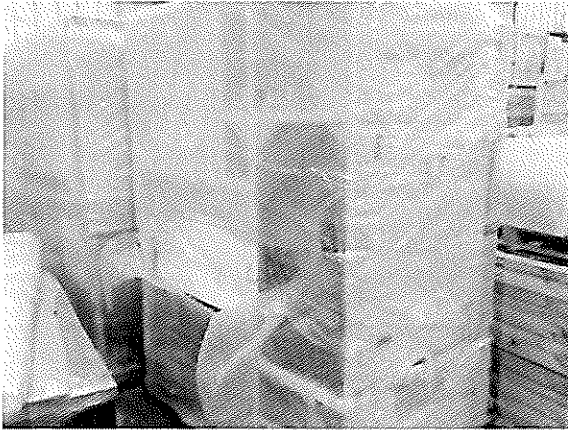
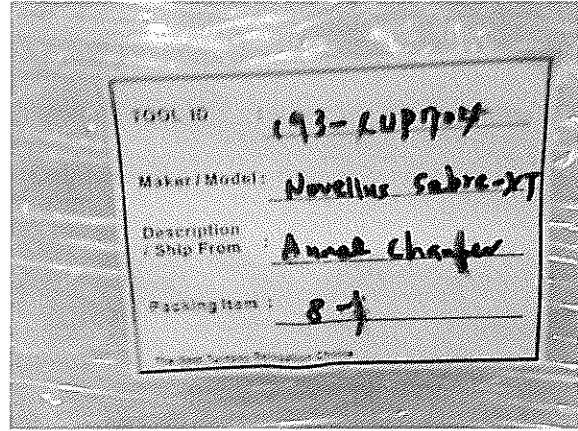
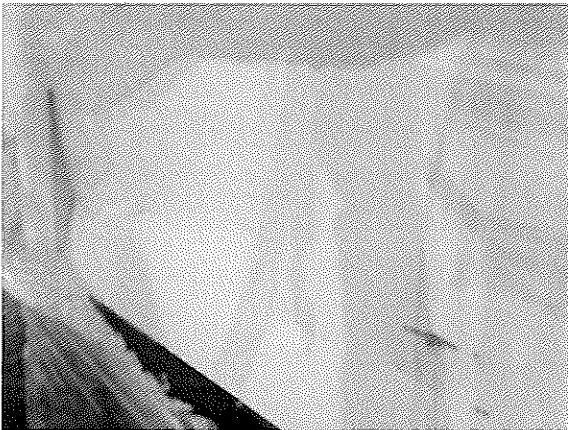
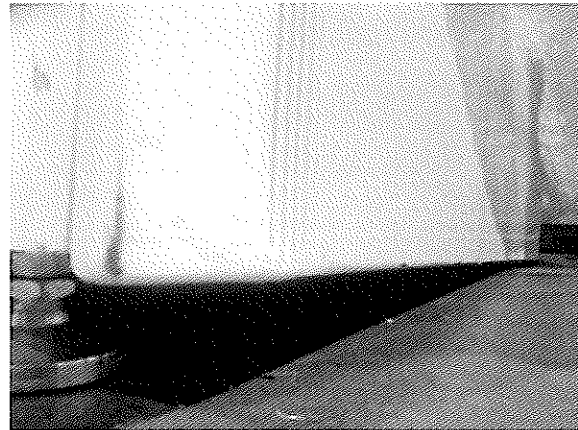
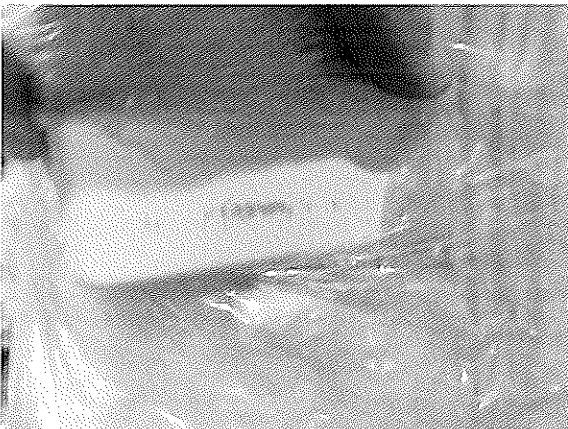
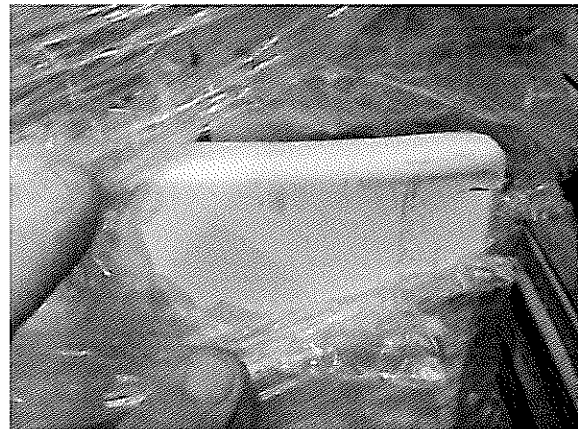
Package# 8-1, description: Anneal Chamber. The unit wrapped with a layer of clear stretch wrap and bubble wrap. The metal side panel found to be heavily dented & scratched. The front panel corners & edges found to be dented and scratched. Front panel dislodged from machine. The plastic & bubble wrapping found with chafing damages and torn in the area of the damages.

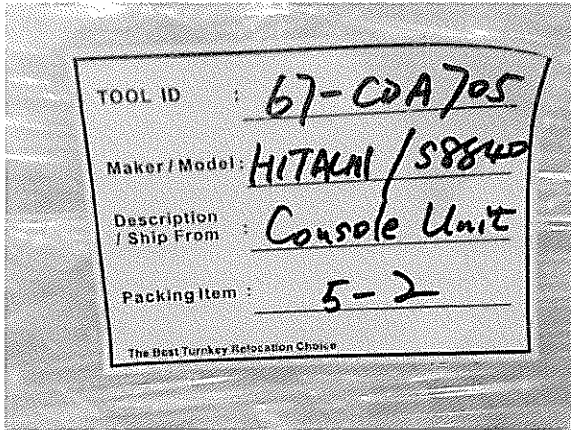
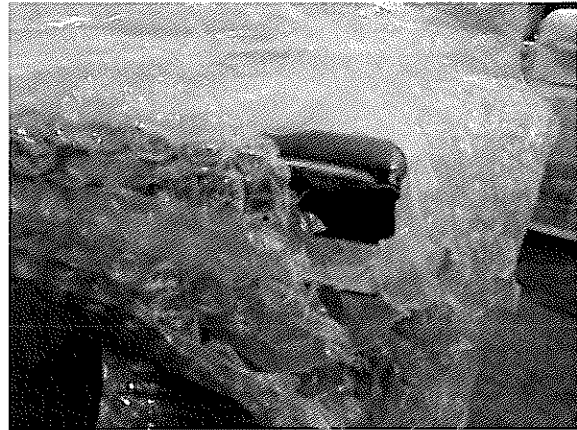
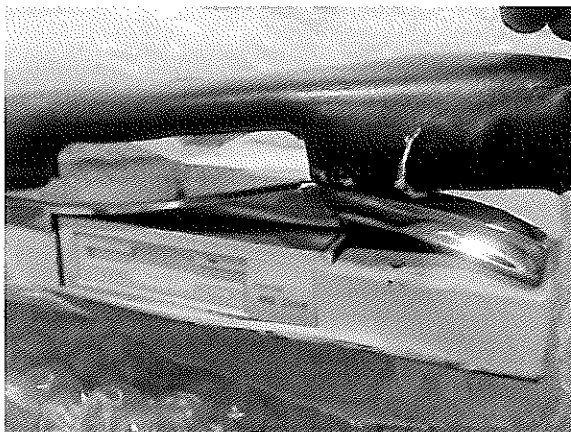
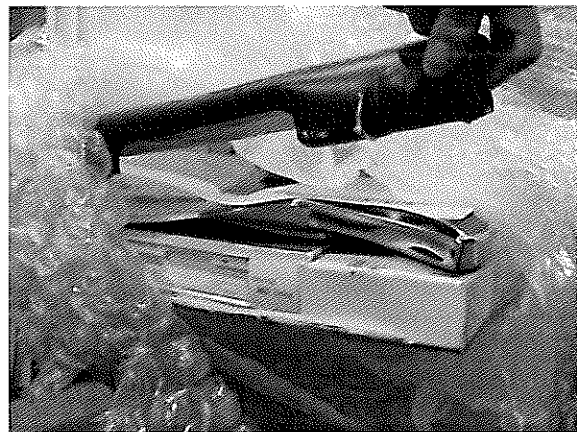
Package# 5-2, description: Console unit. The corner of the control tray on the machine found dented & distorted. The bubble & stretch wrap found torn with chafing in the area of the damages.

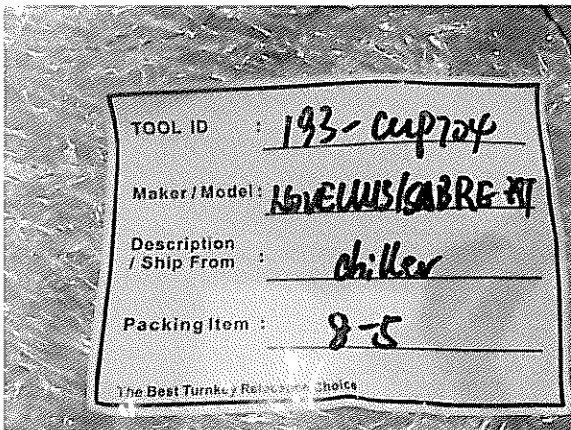
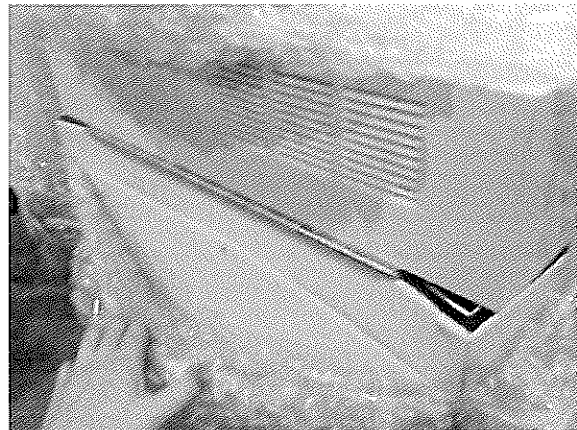
Package# 8-5, description: Chiller. Machine wrapped with a layer of stretch and bubble wrap. The backside of the machine found dented inward and off-alignment.

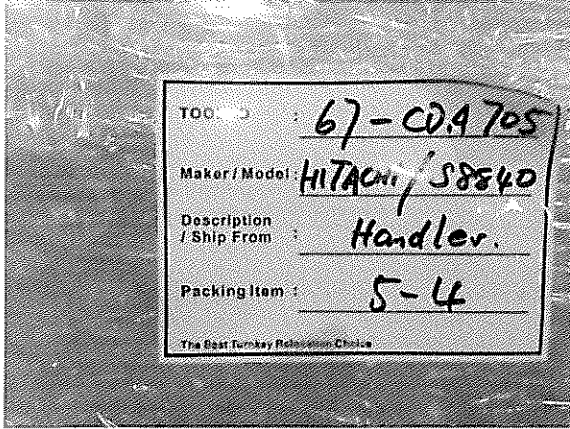
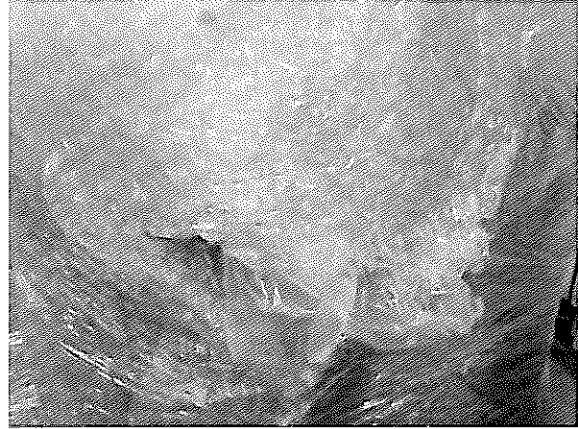
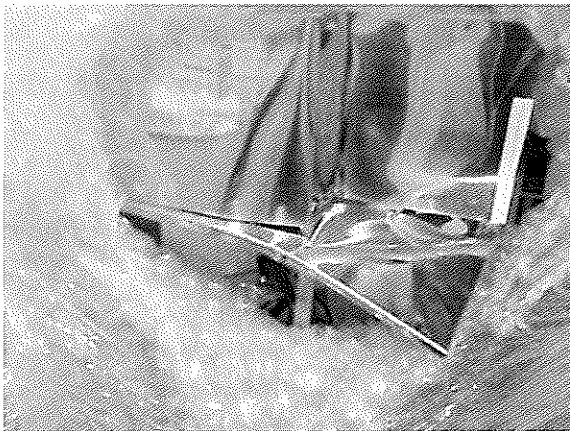
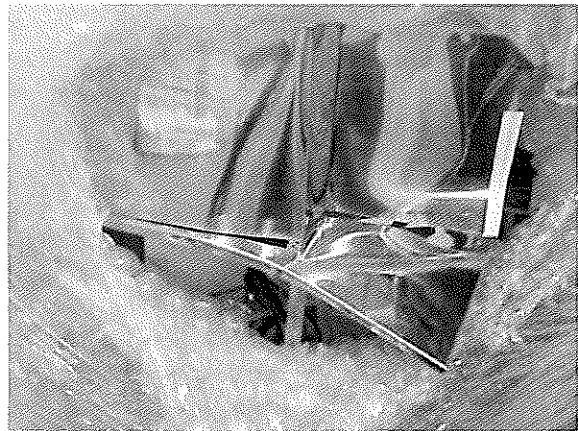
Package# 5-4, description: handler. The machine wrapped with a layer of stretch wrap & bubble wrap. We noted signs of chafing damages and torn packaging material in the area of the damages. The thin metal sheeting and covers on the machine found heavily bent & distorted.

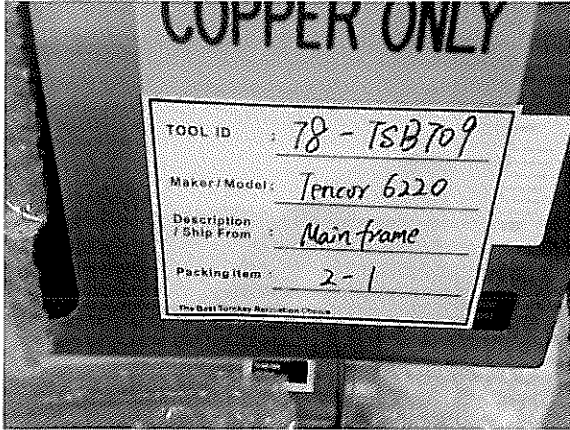
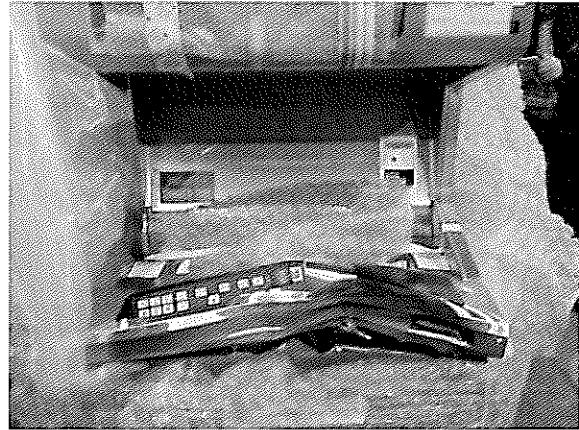
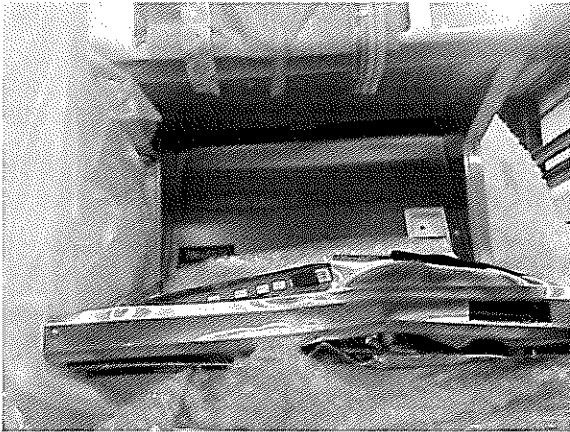
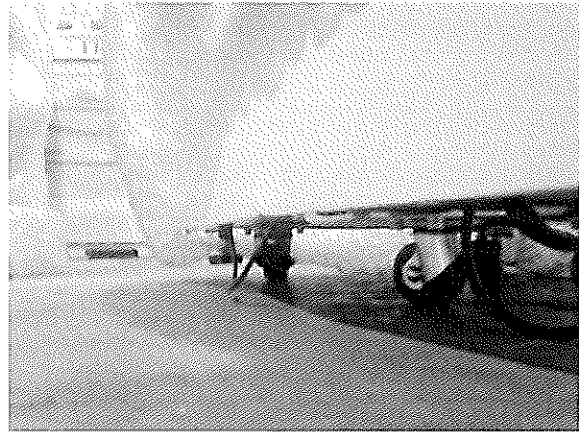
Package# 2-1, description: Main frame. The front of the machine found to be heavily crushed and pushed inward.

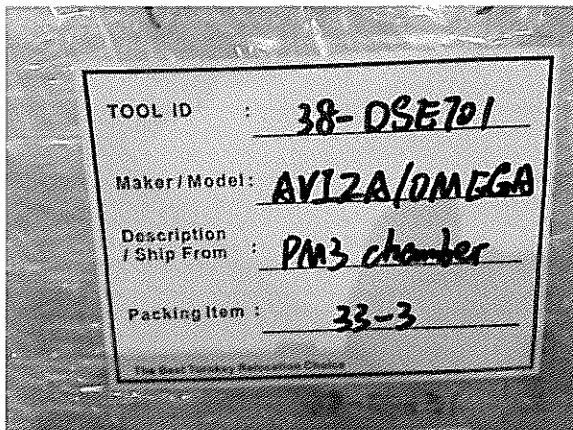
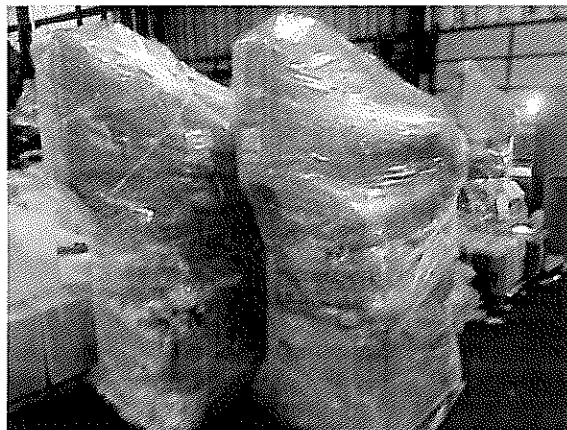
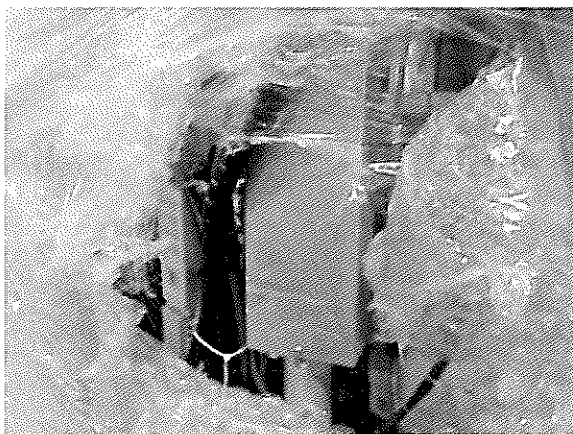
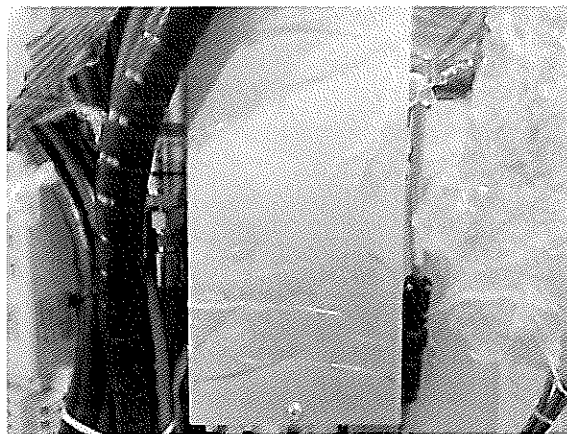
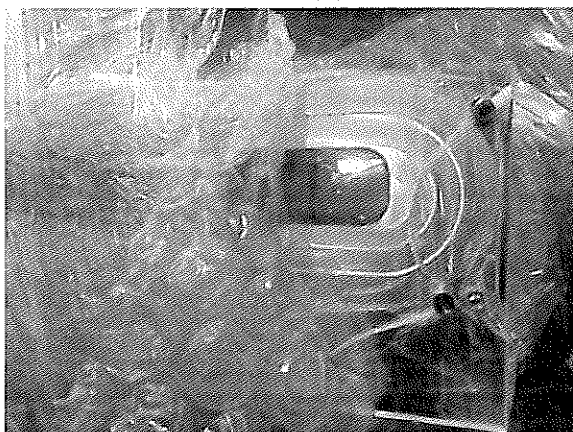
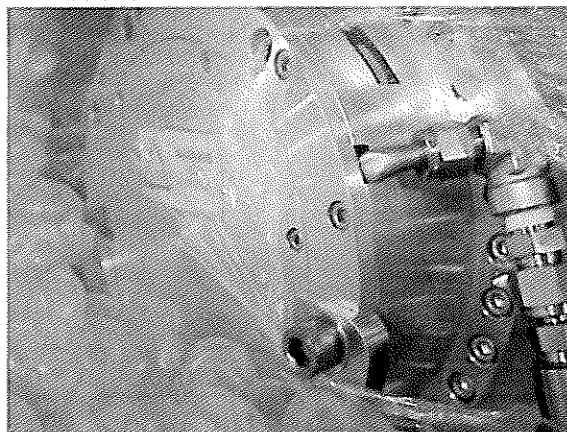
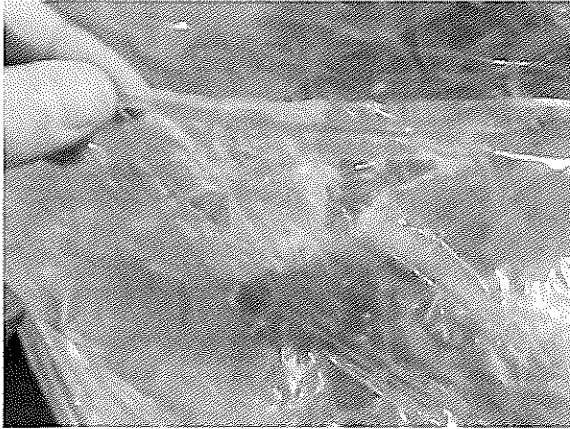
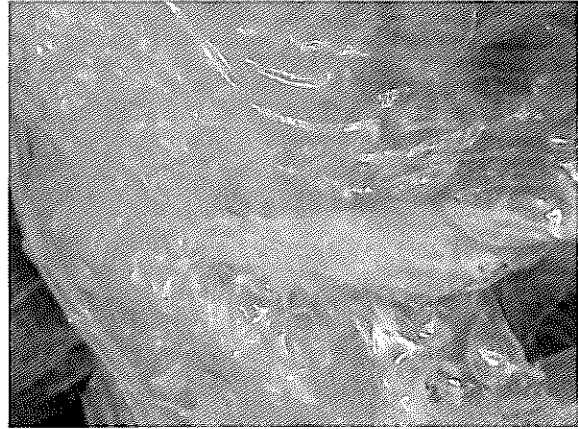
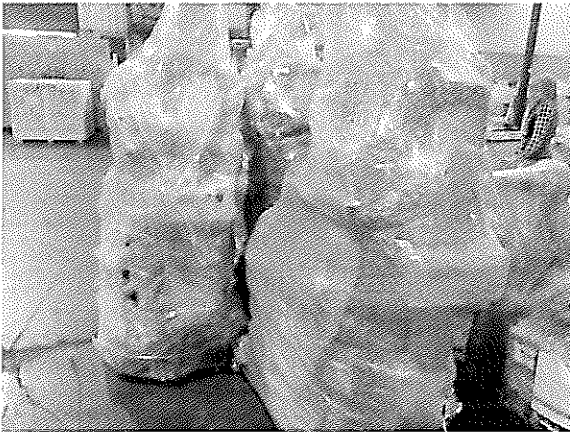
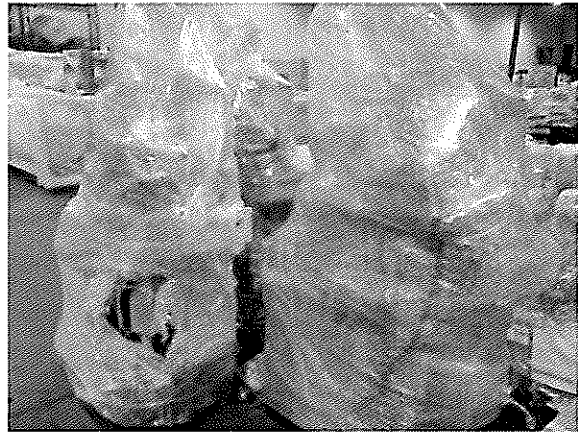
Package# 33-3, description: PM3 chamber. The machine wrapped with a layer of stretch wrap & bubble wrap. We noted signs of chafing damages to the packaging material in the area of the damages.

- The assembly box panel found dented and scratched
- Plexi-glass panel cracked
- Cable fitting bent

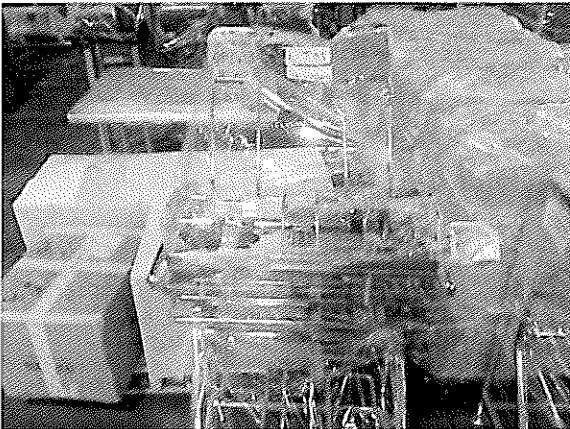
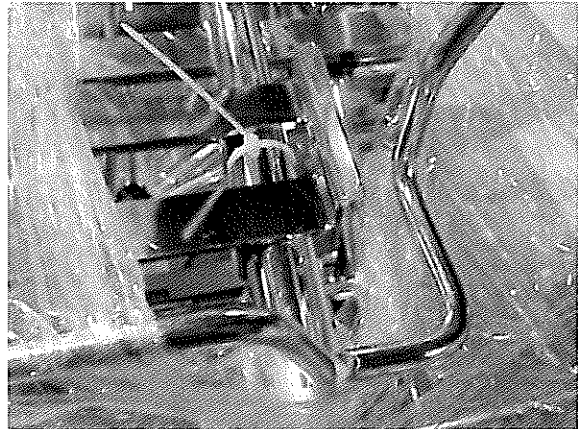
Package no. 4-2, description: Cassette table. The metal rack / cassette table found wrapped with clear stretch wrap, no bubble wrap used. A piece of the metal framing found broken off and separated from the table section.

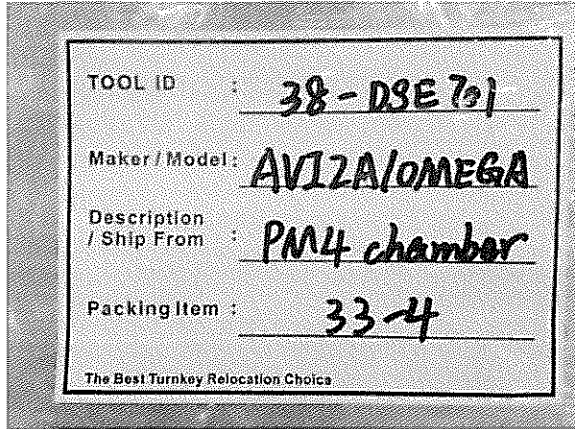
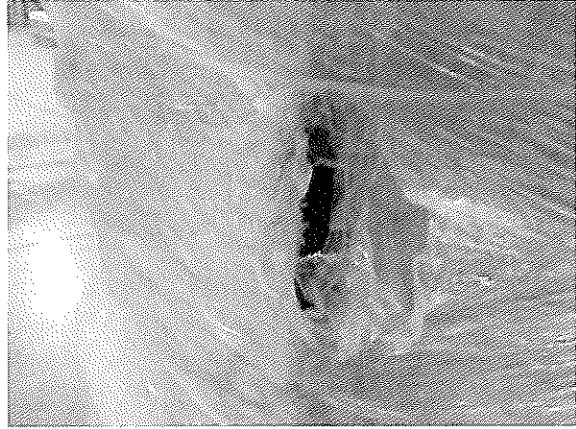
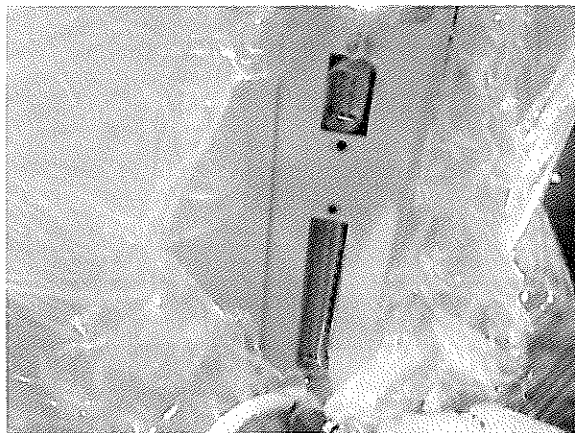
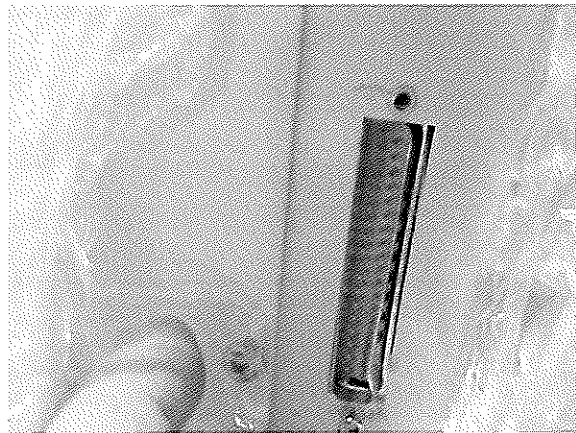
Package no. 33-4, description: PM4 chamber. The machine found wrapped with clear stretch wrap and pink bubble wrap. The plastic & bubble wrapping found with chafing damages and torn in the area of the damages. The (2) connector ports on the backside of the machine found to be bent and distorted.

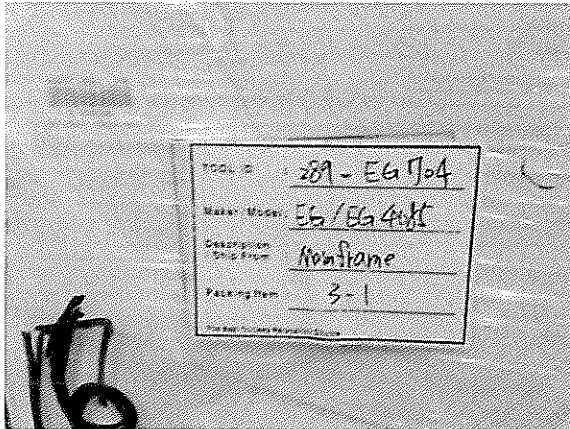
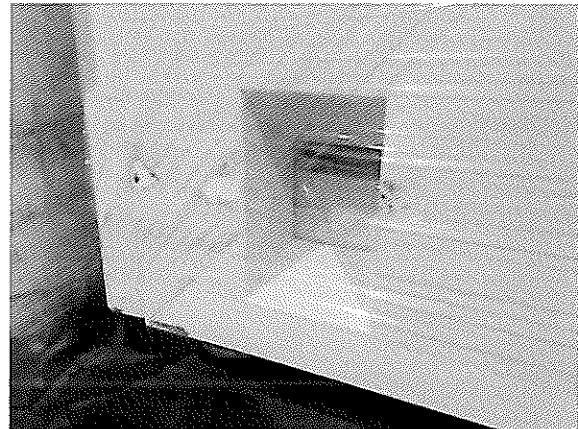
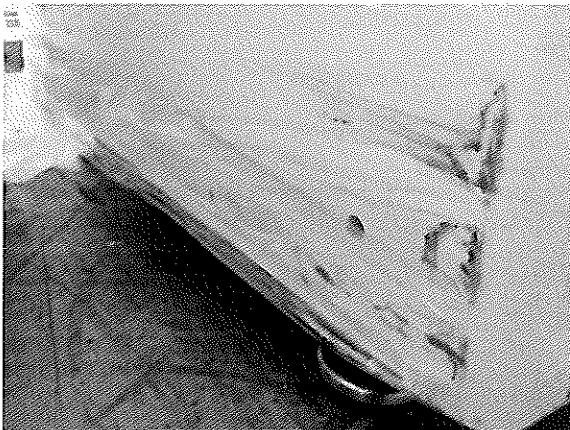
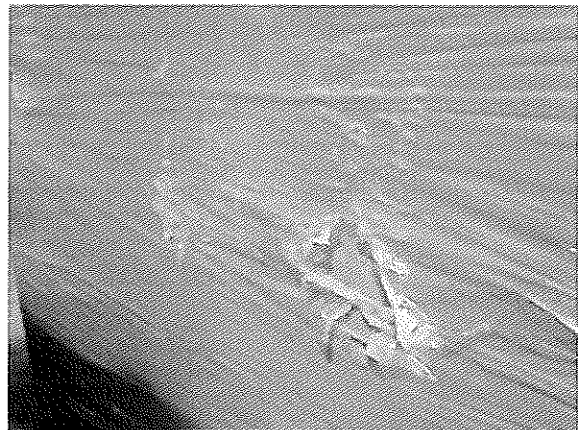
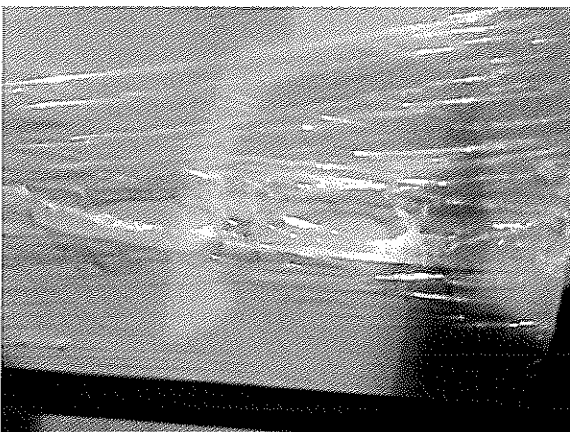
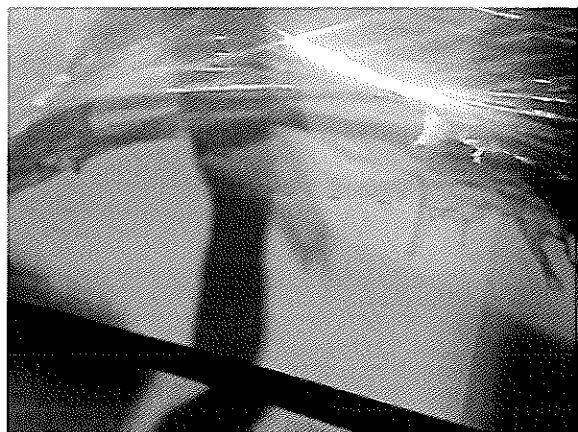
Other machinery found damaged on-site from the factory. A majority of the machine only wrapped with stretch wrap, no bubble wrap. The damages ranged from light to moderate scratches on the machines metal paneling. Clear signs of scuff marks, dirt, and torn stretch wrapping noted on the machines.
